PROPERTY REPORT

We have been instructed to inspect and prepare a Report and Schedule of Condition for XXXX Islington, London. N1 XXX

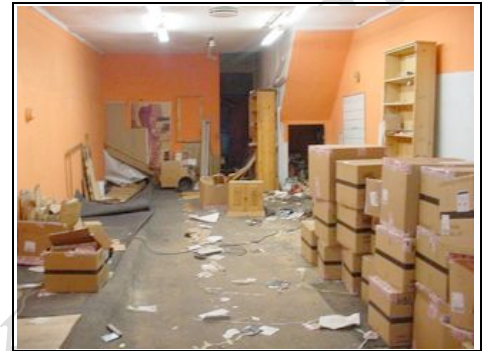
Retail unit

As you are aware a fair amount of money is required to bring this shop unit into good order and indeed what we would term operational standard.

ACTION REQUIRED: Negotiate rent free period, whilst we are not experts in rents in this area we are typically seeing one year free rent periods.

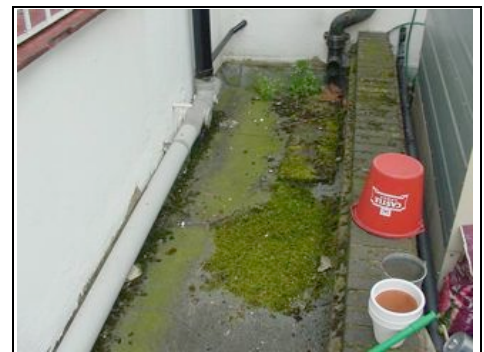
The rear flat roofs are leaking and there are historic signs of water coming in. We believe that this is a combination of issues such as the poor detailing and the flat roof being flat.

Close up of rear flat roof over the shop with moss and signs of leak below

ACTION REQUIRED: Make watertight. We would recommend that any debris is removed from the flat roofs; flashings are checked and replaced with lead flashings. However we feel that the biggest problem is that the rear flat roof is flat in many areas.

ANTICIPATED COST: £5,000 to £10,000 (five to ten thousand pounds) to reform the pitch of the roof, re-deck new felt and new detailing in lead; please obtain quotations.

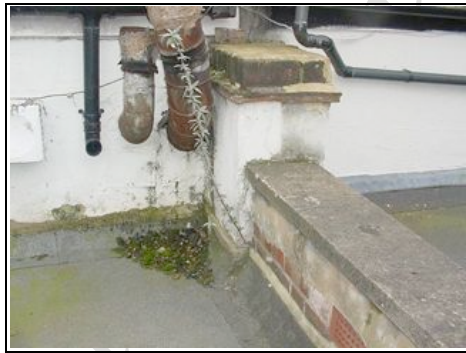
Junction of toilet roof and roof over the shop. Water is discharging onto render which is part of the reason causing dampness below

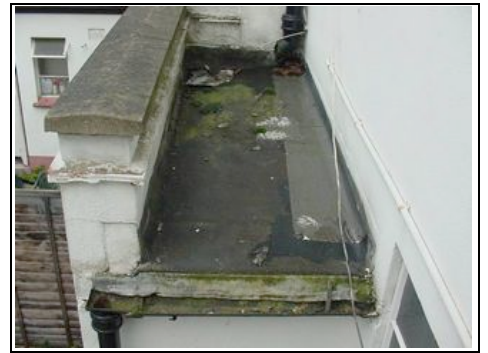
Roof over the entrance, patch repaired in Flashband

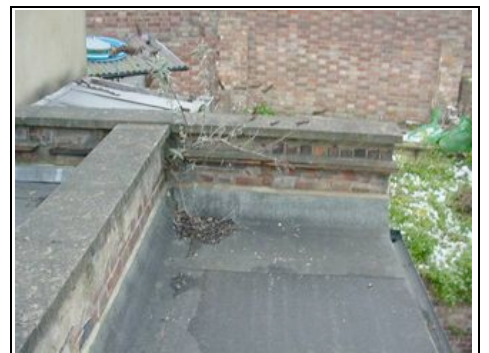
Roof over toilet with tree growing out of parapet wall

Finally we note that the coping stones do not seem to be stopping the water from getting into the parapet walls; these require amendments. A damp proof course underneath and maybe larger coping stones to be installed.

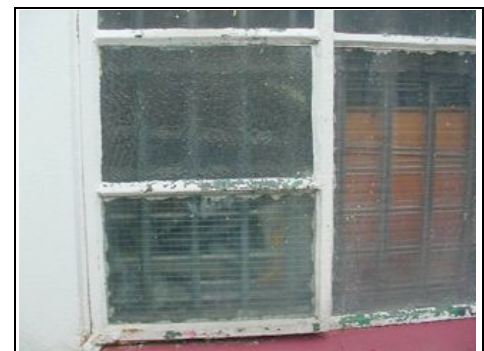
Metal windows

The windows to the rear are metal windows (often referred to by one of the largest manufacturers Crittall windows). Typically these windows warped due to the lack of maintenance and this is what has happened in this case. The warping is so bad that the windows now replacing, repair and secondary glazing or double glazing added.

ACTION REQUIRED: Replace, repair and add secondary glazing.

ANTICIPATED COST: £3,000 to £5,000 (three to five thousand pounds) to replace all the windows and make good the plaster around; please obtain quotations.

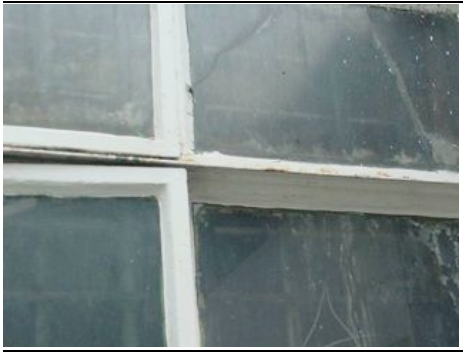
Window not shutting

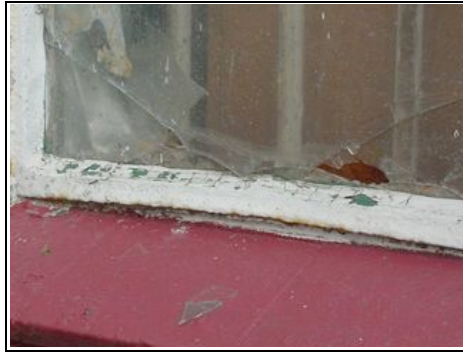
Broken glass in toilet window

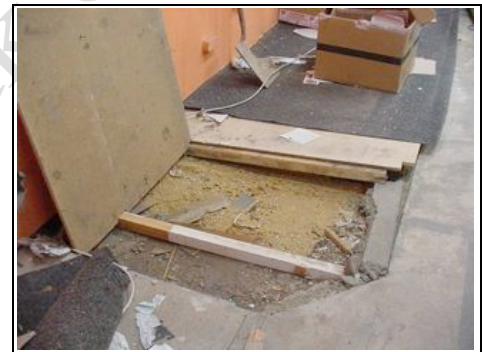
The floor is a suspended timber floor with concrete sections.

Wood flooring to side

ACTION REQUIRED: You need to decide if you wish to have a long term solution or a quick solution to open the property. Most contractors would prefer the quick solution as there is no drying time for the concrete.

ANTICIPATED COST: £4,000 to £7,000 (four to seven thousand pounds) for the floor but does depend upon what is found; please obtain quotations.

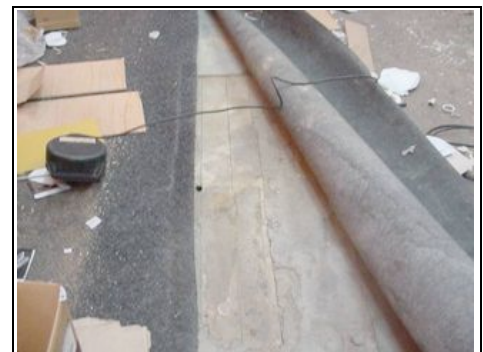
Concrete floor to centre

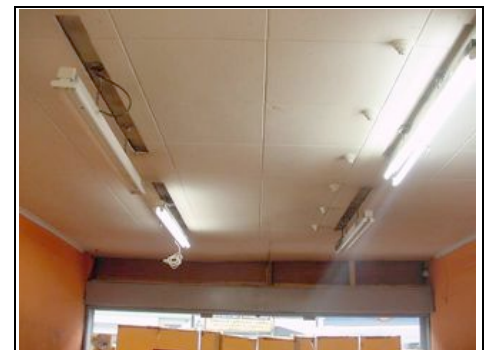
The ceilings have a polystyrene tiles which are generally not used as they are a fire hazard. We recommend that these tiles need to be removed. It is likely that part of the ceiling will come down when the tiles are removed as

Ceiling is water damaged 15

ACTION REQUIRED: Check with your insurers whether polystyrene tiled ceilings are acceptable. You will probably be insured via the owner so we would recommend you send your request in writing with regard to the ceiling finish requirements.

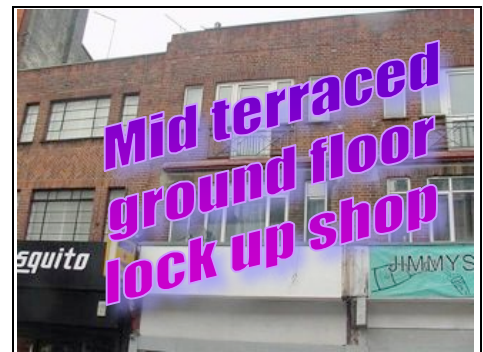
At present the signage is blank with a light box sign next door. Often Planning Permission is required for signage which can take some time via the Local Authority. You need to check to see if Local Authority Approval is necessary for signage.

Signage to front

ACTION REQUIRED: Check Local Authority requirements. Improve signage but adding of insulation and more boarding

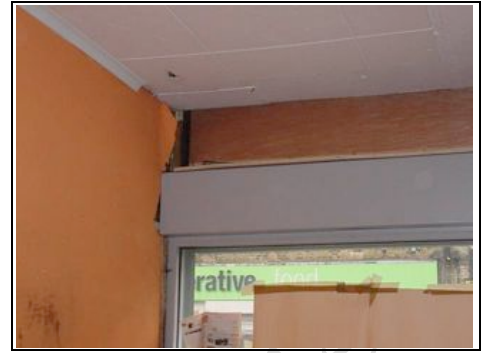
We did notice that the signage literally has a piece of plywood in place which means there is about 10-15mm between you and the outside world which means that you would be heating up much of London if you do not add insulation.

Signage to front literally a piece of plywood

ANTICIPATED COST: A few hundred pounds; please obtain quotations.
