PROPERTY REPORT

We have been instructed to inspect and prepare a Report and Schedule of Condition for XXXX Islington, London. N1 XXX

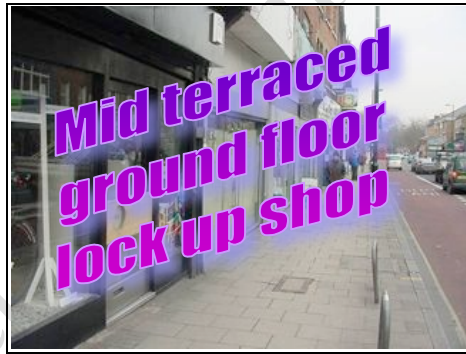
Front Elevation

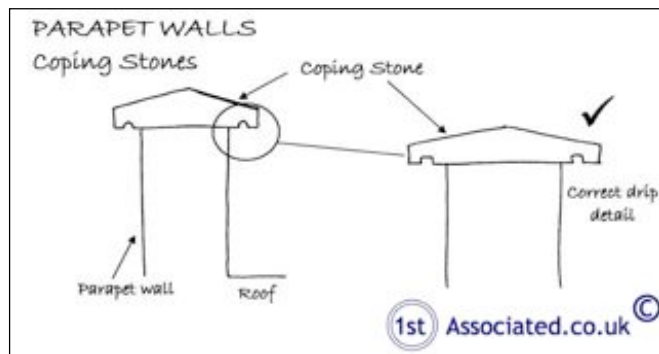
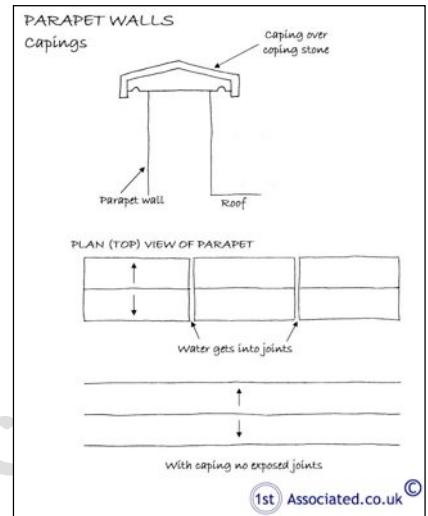
Finally we note that the coping stones do not seem to be stopping the water from getting into the parapet walls; these require amendments. A damp proof course underneath and maybe larger coping stones to be installed.

The sketches show typical problems that we find with coping stones where they are not large enough.

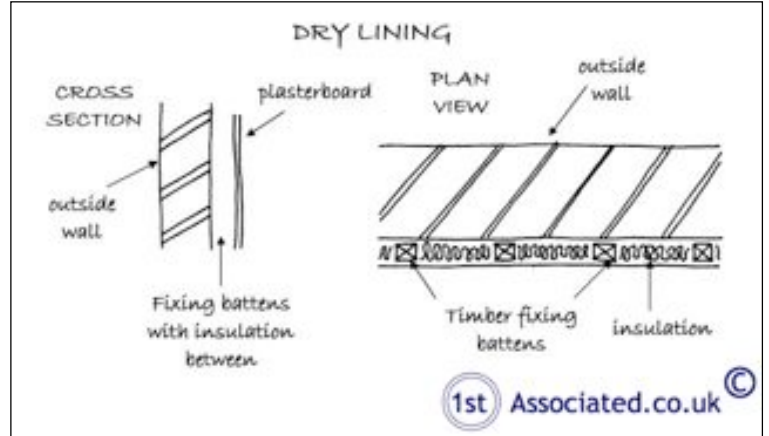
What needs to be understood here is that you have dry lined walls. We mentioned to you in our discussions that the contractors mentioned removal of the walls, we would never recommend this due to the mess and the extra work time.

We would always recommend over-cladding the existing walls, you now have insulation board which is also plasterboard which makes an excellent surface to apply the finish. You do need to ensure that the walls are suitably battened if you intend to hang things off the walls of any weight.

ACTION REQUIRED: Apply a finish to the walls rather than replace.
